Manhole Inspection Summary

Manhole # S21G__007MH

Insp Date: **4/6/09 9:25 AM**

Location Address: **1700 BALTIMORE ST**

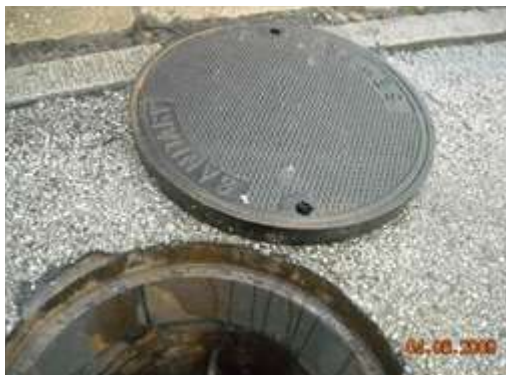
NEW LID

PREVIOUSLY BROKE AND REPLACED
LID WITH NEW 24" SANITARY LID

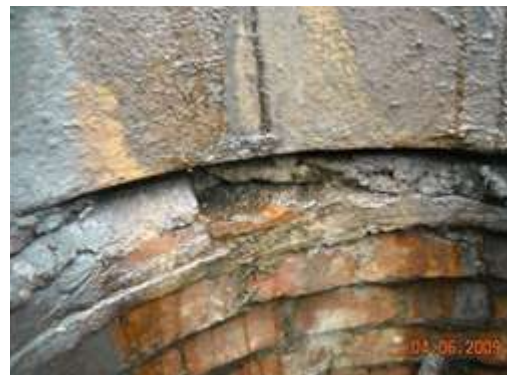
Defect 4

Condition: ☐ Sound ☒ **Cracked** ☐ Root Intrusion ☐ Loose Brick ☐ Deteriorated

Infiltration: ☐ None ☒ **Joint** ☐ Cracks ☐ Mortar ☐ Roots ☐ Wall

CRACKED AND DETERIORATED
CHIMNEY ADJUSTMENT

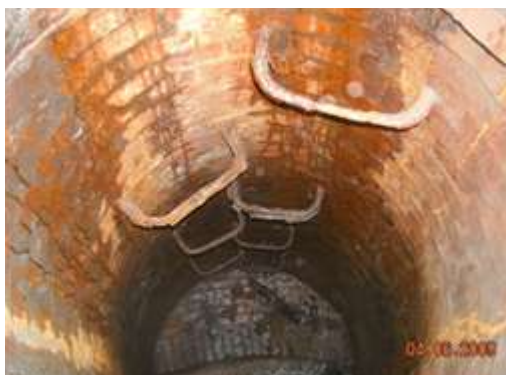
Defect 3

Steps Count: **7** Missing: **0** ☒ **Corroded**

CORRODED STEPS

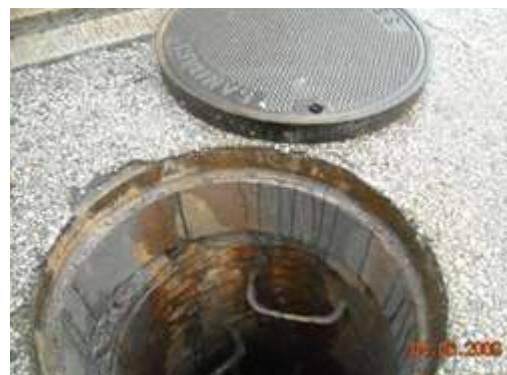
Defect 2

Frame Offset: **2** (in.) Condition: ☐ Sound ☐ Cracked ☒ **Leaks**

FRAME LEAKS/ EVIDENCE OF
INFILTRATION DUE TO SHEETING
FROM ROADWAY

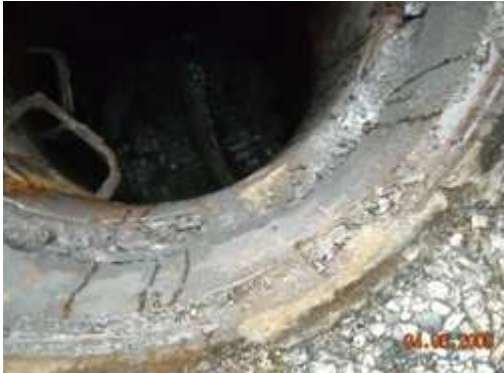
Defect 1

FRAME OFFSET 2"

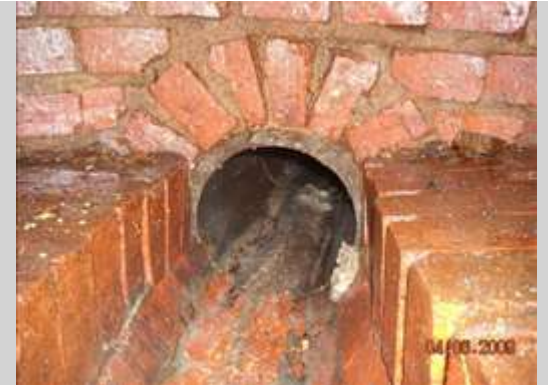
12 O'Clock Outflow

8 in. Circular Gravity Sewer
Pipe Out @ 12 O'Clock

Pipe Height: **8.4** (in.) Rod and Bar (Angled)
Pipe Material: **Clay** ☐ Pipe Lined
Invert Depth: **12.00** (ft.) Flow Characteristics: **Slow**
Deposits: ☒ None ☐ Mud ☐ Sludge ☐ Debris ☐ Grease
Silt Depth: (in.) Deposits Extent:
Infiltration: **None** Pipe Seal Cond: **Sound**

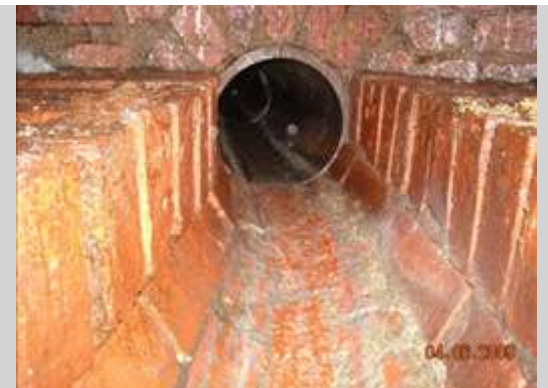
5 O'Clock Inflow

8 in. Circular Gravity Sewer
Pipe In @ 5 O'Clock

Pipe Height: **8.4** (in.) Rod and Bar (Angled)
Pipe Material: **Clay** ☐ Pipe Lined
Invert Depth: **11.65** (ft.) Flow Characteristics: **Slow**
Deposits: ☒ None ☐ Mud ☐ Sludge ☐ Debris ☐ Grease
Silt Depth: (in.) Deposits Extent:
Infiltration: **None** Pipe Seal Cond: **Sound**
